# BELZONA REPAIRS AND PROTECTS TURBINE

ID: 5639

Hydroelectric Plant, Honduras

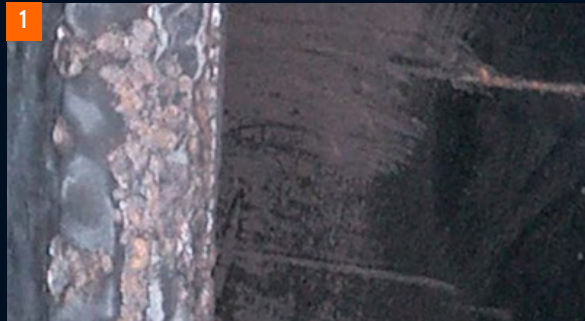
Damage on the 24 turbine blades due to erosion and corrosion. 70% of the blades had the same type of problem.

1. Damage on the turbine blades
2. Application of Belzona 1111
3. Application of Belzona 1321
4. Blades rebuilt and protected

The surface preparation was carried out with mechanical tools, such as grinder, until the area was rough, clean and free from contamination. Belzona 9111 was applied to clean and decontaminate the area. The application was carried out in accordance with Belzona Know-How System Leaflet CEP-1. The application of Belzona 1111 was carried out in 2 hours on 24 blades. After the product cured, it was machined to give the final profiles to the blades. To protect the repair, Belzona 1321 was applied with a brush in a layer of 500 microns.
