# BELZONA REPAIRS TO VACUUM STEAM JET EJECTOR - 3 YEARS AND STILL GOING STRONG

ID: 564

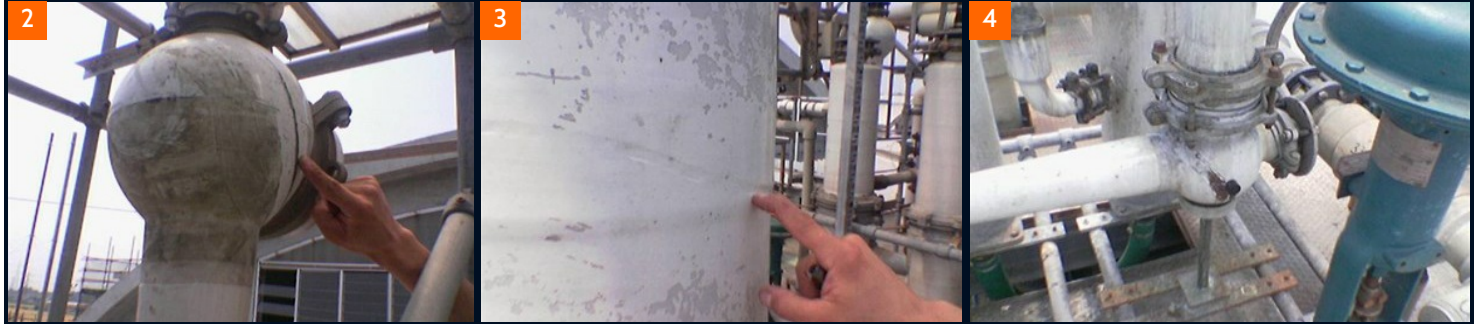
## PHOTOS

The steam jet ejector was fragmented into many parts and a replacement was not immediately available.

Vacuum steam jet ejector handling H<sub>2</sub>O+HCl and Chloride traces. Temperature up to 100°C (212°F). Maximum pressure 13 Bar.

1. View of the first repair where Belzona 1391 was used
2. Damage to the bowl is clearly evident
3. & 4. Other similar equipment which has been repaired

Application has been in service 24 hours a day for three years. Belzona® 1391 was chosen due to the temperature which could from time to time, go higher. Other steam jet ejectors have been repaired at this facility with Belzona® 4301 (Magma CR1 Hi-Build) with the same excellent results. The replacement - ordered some three years ago - remains in stock.
