# BELZONA PROTECTS VALVE SEAL AREA

ID: 5640

Valve Seal in the turbine.

Hydropower Plant, Honduras

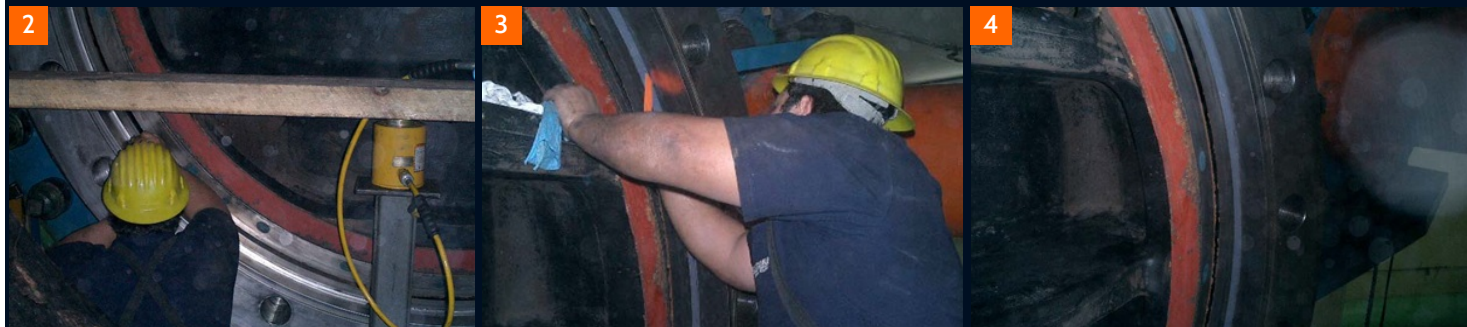
## PHOTOS

Valve with erosion problems in the perimeter of the seal joint. In certain areas there were small holes but in other areas there were deeper holes.

1. Valve with cavitation problems
2. Surface preparation
3. Application of Belzona 1321
4. Completed application

The surface was prepared with emery paper and later cleaned with Belzona 9111. The application was carried out in accordance with Belzona Know-How System Leaflet GSS-1. The application formed a protective barrier against water damage.
