# BELZONA SYSTEM PROTECTS FLANGES AND BOLTS FROM CORROSION

ID: 5643

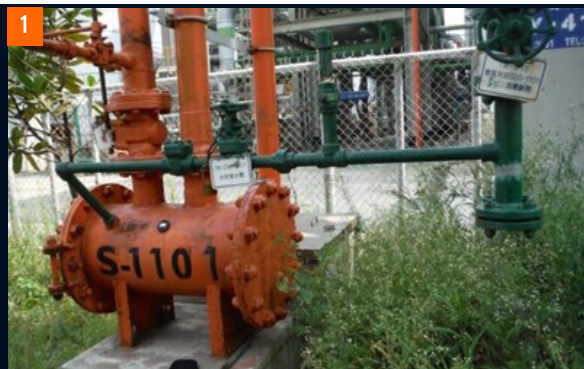
The flanges and bolts were suffering from corrosion problems due to high humidity from the nearby coast.

The vertical shut-off valve's flange was suffering from corrosion caused by trapped water which leads to frequent equipment replacement. Applying the Belzona 3411 system protects the fire extinguishing system from corrosion and weathering.

1. Overview of the fire extinguishing system.
2. Applying Belzona 8411 as a corrosion inhibitor after the surface preparation.
3. Applying Belzona 3411.
4. Completed application.
