# BELZONA FLANGE ENCAPSULATION SYSTEM PROTECTS FIRE SYSTEM

ID: 5644

Cogeneration plant, Taiwan

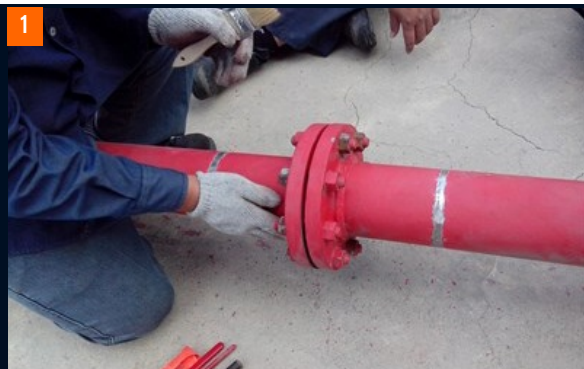
The flange and bolts were suffering from corrosion problems due to the coast nearby.

1. Overview of fire extinguishing system
2. Surface Preparation and applying 8411 as a corrosion inhibitor.
3. Applying Belzona 3411
4. Application completed

The plant is near the coast and the flange and bolts are exposed to humid environment which caused corrosion problem, such as crevice corrosion. Applying Belzona 3411 system protects the fire extinguishing system from corrosion whilst allowing easy inspection when required.
