# BELZONA NEW GENERATION HIGH TEMPERATURE LINING PROTECTS DESULFURIZATION UNIT

ID: 5648

Reboiler in the Desulfurization unit.

Natural Gas Purification Plant, South East of China

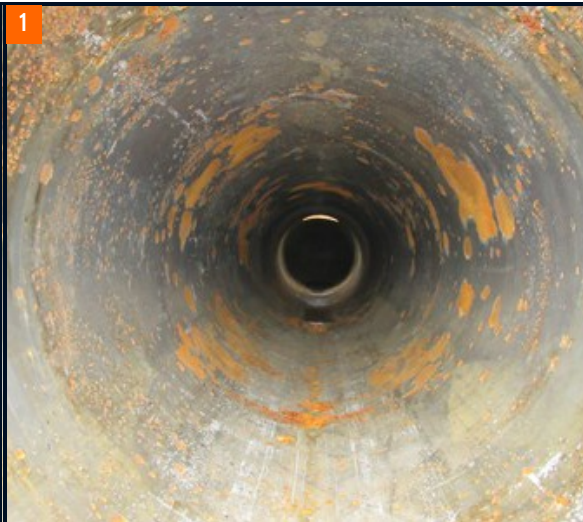
The vessel operates at 150°C (302°F) and 1.6 MPa (232 psi) pressure. The amine media, rich in H<sub>2</sub>S, is extremely corrosive, leading to severe pitting and thinning of the vessel wall, thereby increasing operational risks.

1. Interior of the vessel before surface preparation
2. Surface preparation by grit blasting under way
3. Rebuilding pitted areas with Belzona 1511
4. Finished application with 2 coats of Belzona 1593 after inspection

The application was carried out in accordance with Belzona Know-How System Leaflet TCC-5. Belzona 1511 was used to fill the pitted areas and two (2) coats of Belzona 1593 were applied for overall corrosion protection.
