# NO JOB IS TOO SMALL FOR BELZONA

ID: 565

Yamaha YZ 250 cc - 2001

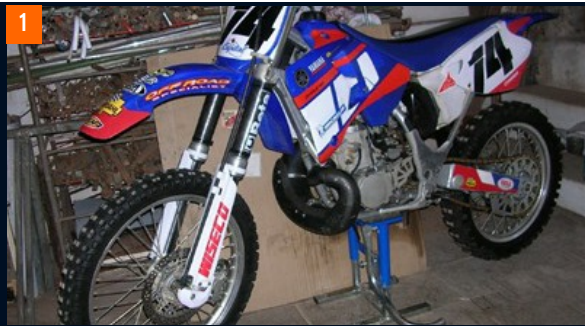
Activities during a motocross race caused a stripped thread. Piece of equipment quite expensive.

1. Yamaha YZ 250
2. Broken thread
3. Completed work
4. See the rebuilt fillet

Application was carried out in accordance with Belzona Know-How System Leaflet ENC-2. The area was post-cured at 50° C for five hours to ensure that the oil seals were not damaged.
