# BELZONA TANK BASE SEALING SYSTEM OFFERS COST-EFFECTIVE SOLUTION

ID: 5650

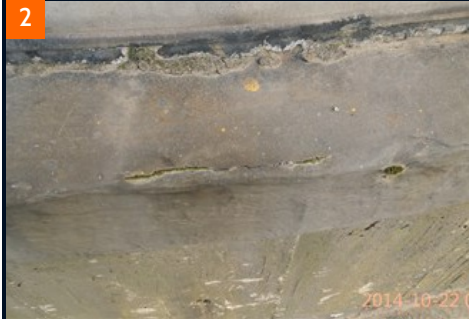
The original tank base seal cracked allowing moisture penetration to tank base. This led to corrosion under the tank base.

1. Overview of the tank farm
2. Damaged tank base
3. Applying Belzona 3211
4. Completed application
