# BELZONA REPLACES PTFE LINING AND CUTS DOWNTIME

ID: 5655

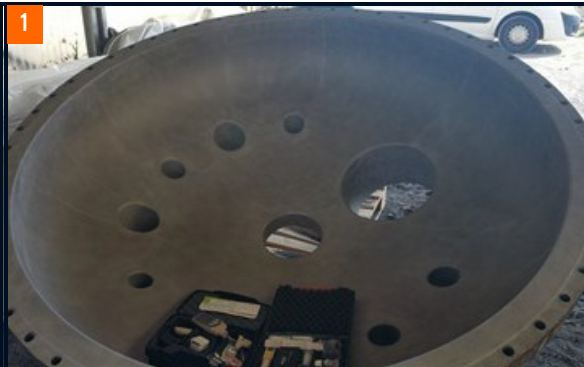
The original hot applied PTFE Lining required maintenance due to localised disbondment. The plant was facing a long downtime as it was not possible to conduct an in-situ repair of such a lining. The customer was looking for a solution that was faster and easier to apply.

1. PTFE lining removed
2. Belzona lining applied
3. Coating thickness measured
4. Inspected after 6 months in service

The application was carried out in accordance with Belzona Know-How System Leaflet TCC-5 for protecting and rebuilding steelwork. After grit blasting to SA 2.5, a two-coat system of Belzona 1593 was hand applied to an area of 25 m<sup>2</sup>.
