# BELZONA PROTECTS NEW VACUUM PUMPS

New vacuum pumps at paper machine manufacturer in need of erosion and corrosion protection.

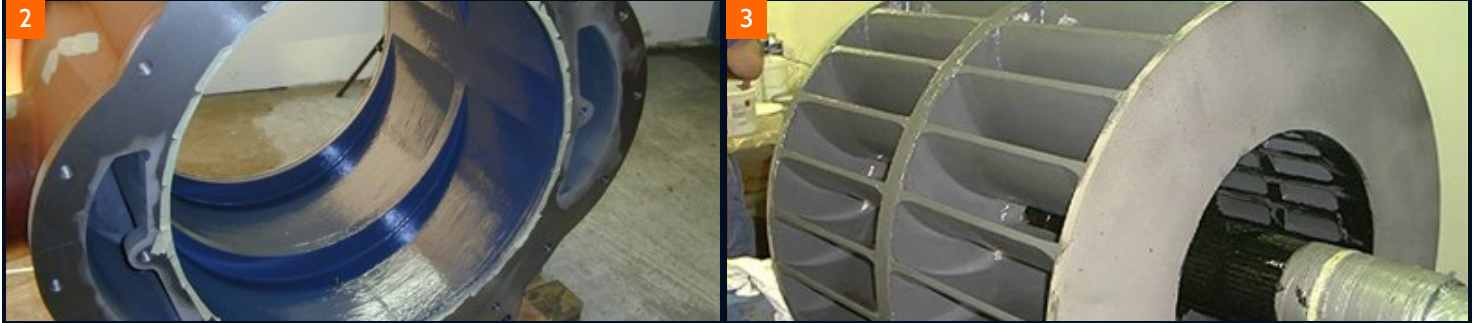
1. New rotors 2. Protected pumps 3. Application on a rotor

The pumps rapidly deteriorate in service due to contamination of the water seal with acid leading to severe erosion corrosion. Preventive treatment required to extend service life of the pumps.

Application was carried out in accordance with Belzona System Leaflet PDP-5.

Belzona 1321 (Ceramic S-Metal)
