# BELZONA EXTENDS THE LIFE OF A CLEANER HEAD CONE

ID: 5659

Cleaner head at a paper mill.

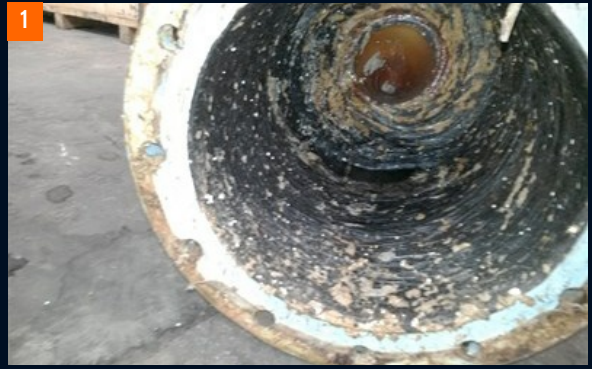
The cleaner head was worn out after 4 months due to the highly abrasive environment. The paper mill wanted the head to last longer.

1. Erosion damage to the head
2. Interior rebuilt with Belzona 1812
3. Installation of Alumina Tiles
4. Completed repair
