# BELZONA REPAIRS AND PROTECTS CORRODED SHELL

ID: 566

Heat exchanger shell

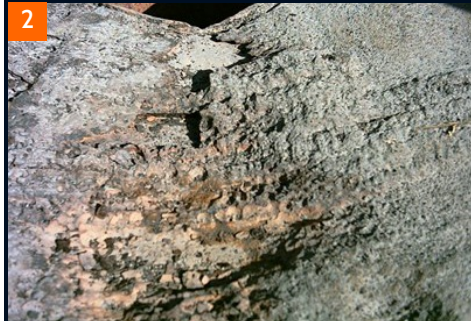
1. General view of the shell and cover.
2. The corroded surface inside the shell.
3. Forming the applied Belzona Marine Metal.
4. Belzona Marine Metal rebuild successfully completed. Belzona 1321 applied to provide overall corrosion protection.

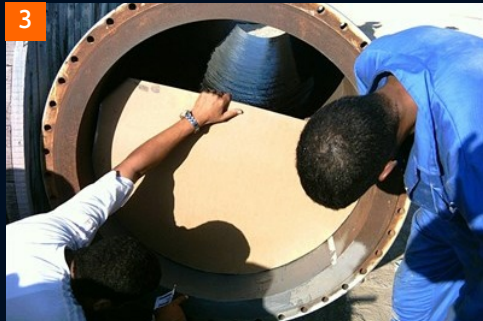
Shell and dished end were highly corroded due to chemical attack that resulted in critical wall thickness reduction in the shell.
