# FIRE TRUCK PUMP GETS NEW LIFE WITH BELZONA

ID: 5660

Fire truck pump.

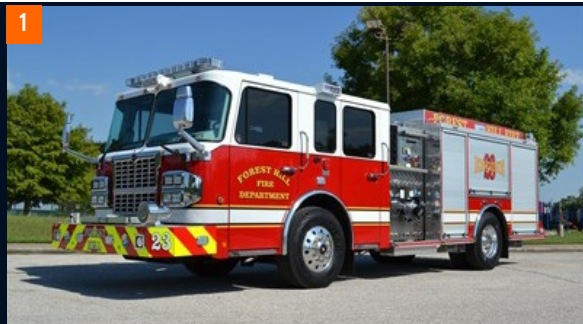
The pump had suffered severe corrosion due to intermittent use.

1. View of the fire truck
2. Blasted pump
3. Coated pump
4. Coated valve body

The application was carried out in accordance with Belzona Know-How System Leaflets CEP-1 and CEP-3. Pump was blasted and repaired with Belzona 1111 prior to being coated with Belzona 1341.
