# BELZONA REPAIRS A BULLET HOLE ON A MEMORIAL

ID: 5661

City park memorial statue.

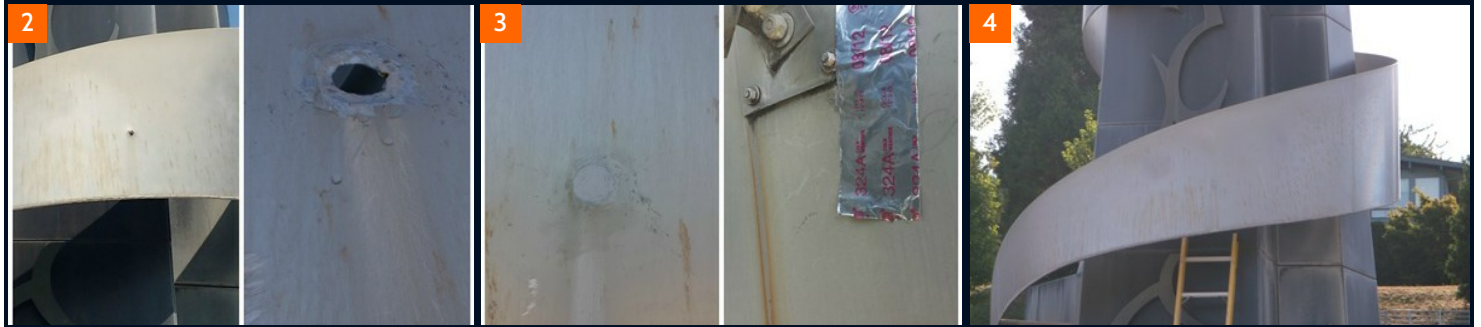
Someone had fired a bullet at the statue. The bullet struck the metal band from behind resulting in a mushrooming effect out of the face. This statue has water running over the front of it and because of the metal being pushed out from the bullet it was beginning to streak and stain causing discoloration of the metal.

1. The statue with the bullet hole visible.
2. The bullet hole up close / The bullet hole prepped.
3. The completed repair. Front / Back.
4. The repair from 40' away, virtually invisible.

The damaged metal was ground down leaving a rough and slightly concave area. The Belzona 4111 resins were mixed and used to condition the surface. The Belzona 4111 aggregate was then added to the resins until it was of a thick and "dry" consistency. A piece of tape was mounted to the back after applying a layer of Belzona 4111 to hold the Belzona 4111 in place until it cured. The front surface was then packed full and tight, then the excess was carefully removed, and the remaining Belzona 4111 smoothed off.
