# BELZONA PROTECTS STERN TUBE (BEARING AREA) ON A US NAVY SHIP

ID: 5663

Stern Tube on a U.S. Navy Ship

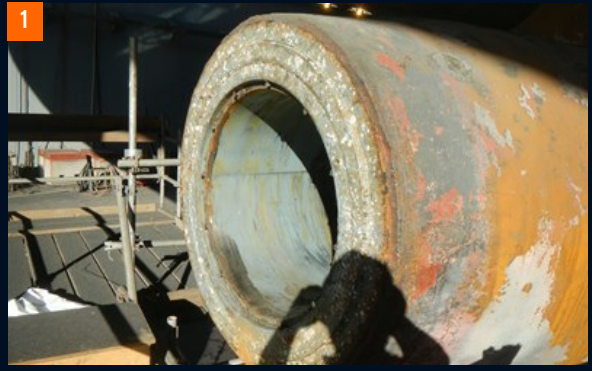
1. Stern tube of the ship after tail shaft removed
2. Inspection after grit blasting
3. First coat of Belzona 1341
4. Completed application

The U.S. Navy required superior protection against erosion and corrosion in the bearing area of the stern tube when the ship was dry docked.
