# BELZONA PROTECTS A STERN TUBE (NON-BEARING AREAS) ON A A US NAVY SHIP

ID: 5664

Stern Tube on a U.S. Navy Ship

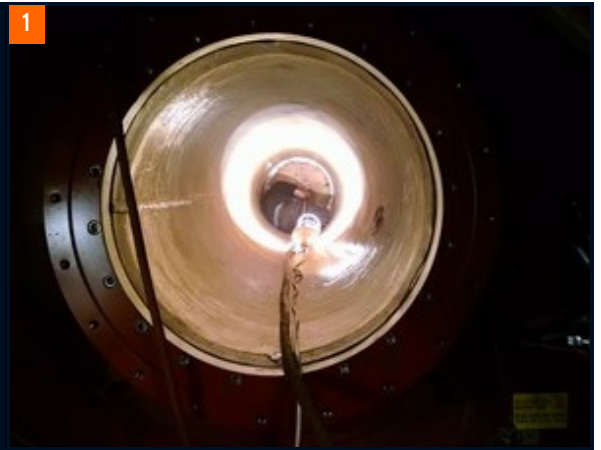
1. Stern Tube Preparation
2. Stern Tube Coating
3. Completed Stern Tube Coating

Areas in stern tube were spot repaired with Belzona 1111 and then coated with a brush.
