# BELZONA SUPERWRAP II ENSURES THE SAFETY OF AN OFFSHORE PLATFORM

6" diameter riser on an offshore platform.

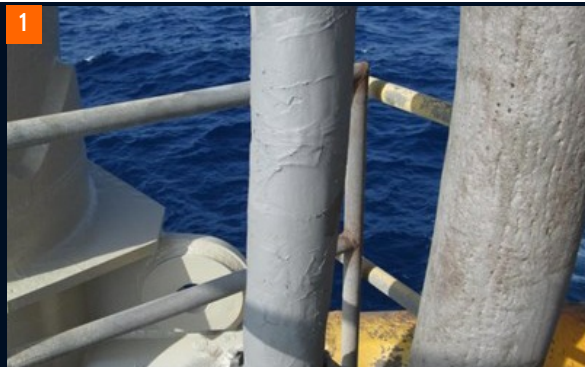
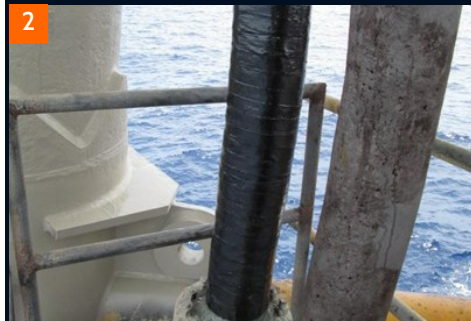
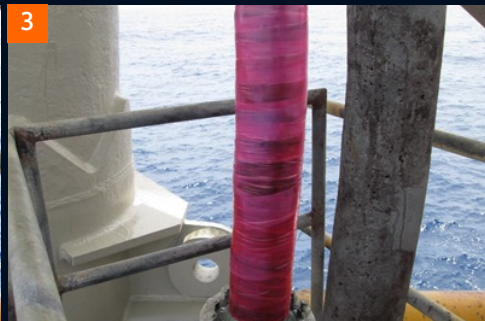
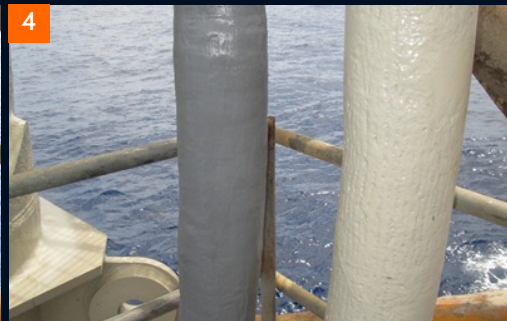
## PHOTOS

The integrity of the riser was compromised due to severe damage caused by external corrosion. The asset owner needed to protect the surface of the riser without any interruption to the operation. Hot work was not an option.

1. Belzona 1121 applied to fill pitting
2. Four wraps (8 layers) of Belzona 1982 applied
3. Belzona 9382 applied to consolidate repair during cure
4. Complete application - Belzona Superwrap II repair overcoated with Belzona 1121 prior to application of urethane topcoat

The substrate was grit blasted to produce a surface cleanliness of SSPC-SP 10 (Near White Metal) with an anchor profile of at least 3 mils (75 microns). The surface was then cleaned and degreased and the condition of the blasted surface was maintained until the application of the repair system. Belzona 1121 was used to fill pitted areas and to restore the original pipe thickness. Belzona 9381 was saturated with Belzona 1982 and applied onto the pipe in 4 wraps (8 layers) in compliance with the engineered design. To consolidate the repair during the curing process, Belzona 9382 was employed. After 24-hour cure, Belzona 9382 was removed. The surface of the cured Superwrap II was washed and sanded, and the pipe was overcoated with Belzona 1121 prior to application of a urethane top coat.
