# RISER BOOT TOPPING PROTECTED WITH BELZONA

ID: 5668

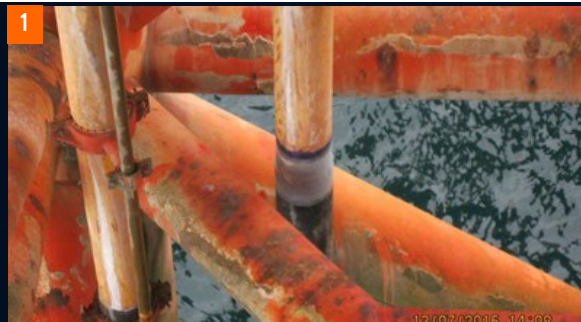
1. Substrate prepared for application
2. Application of the first layer of Belzona 3411
3. Completed application

The application was carried out in accordance with a modified version of Belzona Know-How System Leaflet SOS-21. After cutting back the loose Neoprene cladding and preparing the surfaces, Belzona 1321 was applied to the steel riser and blinded with Belzona 9231 (Surefoot Aggregate) to provide an anchor pattern for the application of Belzona 3411. Belzona 3911 was applied onto the Neoprene to achieve adhesion before the Belzona 3411 system was applied to bridge over the steel/neoprene junction. A bond breaker tape was applied at the junction to optimise movement at this point.
