# BELZONA EMERGENCY LEAK SEALING

ID: 567

Tube sheet in nitrogen production unit working at 8 bar

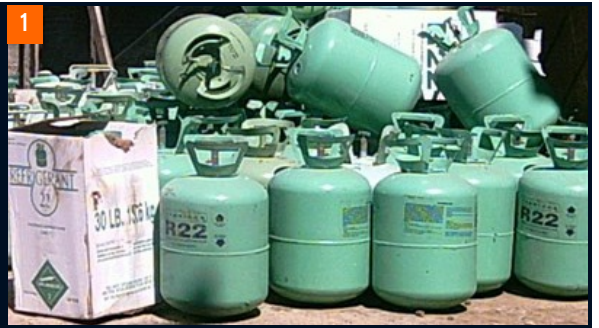
1. General view of the consumed Freon containers used to replenish leaks.
2. The tube sheet suffering from Freon leakage
3. Surface preparation by grit blasting
4. Belzona 1321 applied to stop the leakage

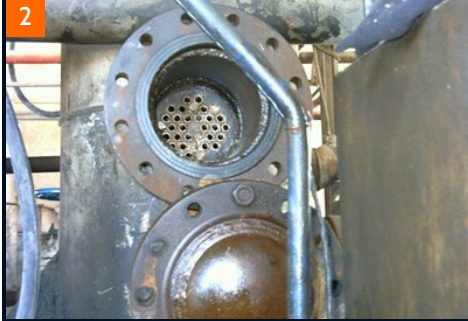
Bi-metallic corrosion between the tubes and the tube sheet had caused Freon leakage.
