# BELZONA RESCUES A 100-YEAR OLD PENSTOCK

ID: 5672

Steelwork of 10 foot diameter penstocks in a Hydropower plant.

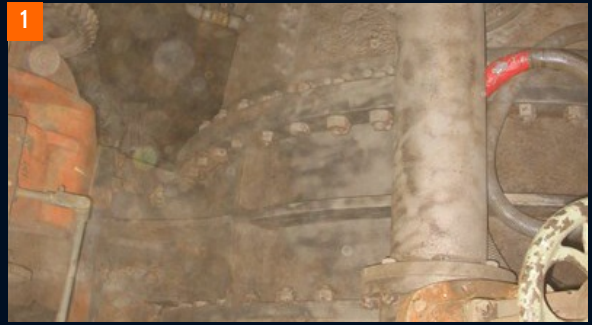
1. Penstock embedded in concrete thrust block at base of the dam
2. Pinholes discovered during the work
3. Surface prepared by blasting
4. Completed application

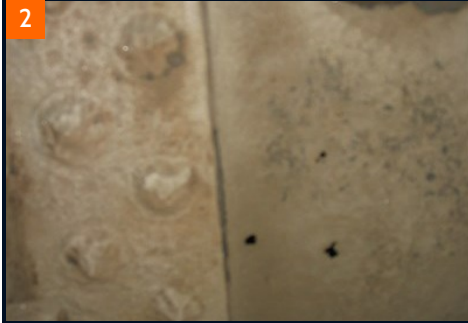
100 plus year old steelwork was corroding from moisture. The problem was detected when installing new control valves and trash racks on penstocks.

The surface was properly prepared by abrasive blasting. First, the pits and holes were repaired with Belzona 1121 and then overcoated with Belzona 5811.
