# BELZONA 1311/1321, 10+ YEARS AND STILL GOING

ID: 568

## PROBLEM

Extensive pitting corrosion and erosion in bottom of the vessels and around a manway.

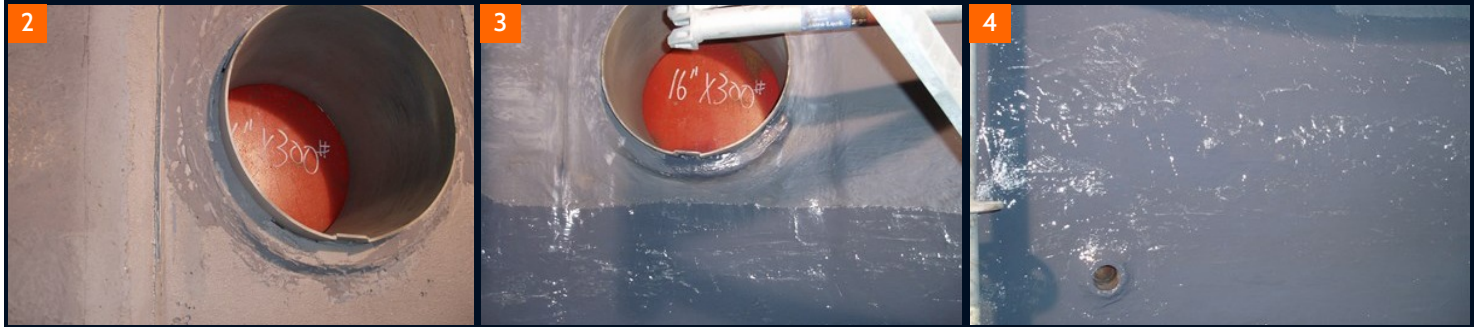
1. 10 year old Belzona 1311/1321 system
2. 10 year old Belzona blast cleaned
3. New Belzona 1311/1321 system applied
4. Vessel interior with a fresh Belzona 1321 two coat system applied

Belzona® 1311/1321 was applied to these vessels 10 years ago. 80% of product was still in excellent shape and was only frost blasted to allow for a new coat. Severe pitting corrosion had occurred in areas that were not protected by the Belzona system 10 years earlier.
