# BELZONA SMOOTHS AIRPORT RUNWAY

ID: 5685

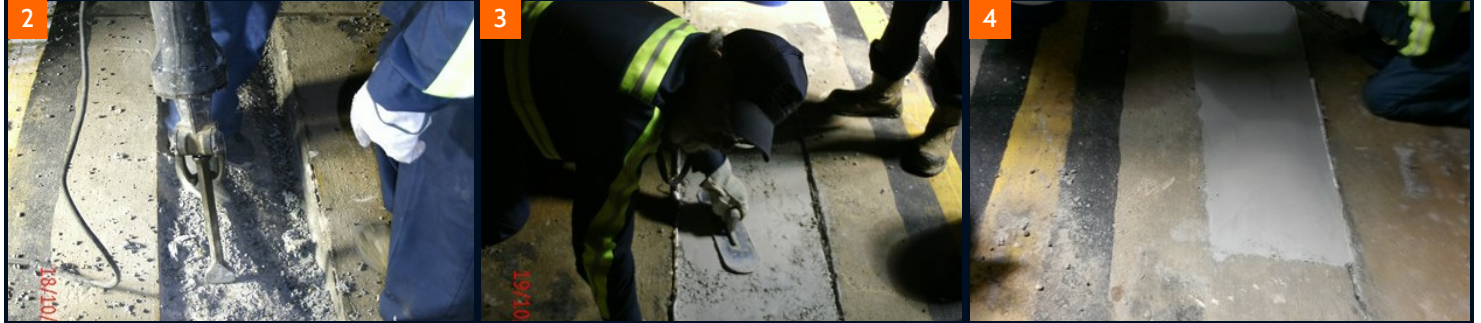
## PHOTOS

Prior patching material failed. A steel plate was used to cover the hole.

1. Old patch failed and removed
2. Hole prepared for application
3. Bulk material to fill the hole
4. Finished with pure Belzona 4111

The application was carried out in accordance with Belzona Know-How System Leaflet FPA. Old and loose material was removed. Then, a mixture of gravel and Belzona 4111 was used to bulk up the patch. A batch of pure Belzona 4111 was used to finish the job.

The material was applied at 11:00 PM and the runway was open by 8:00 AM.
