# BELZONA TAKES THE SLIP OUT OF THE FLOOR

ID: 5686

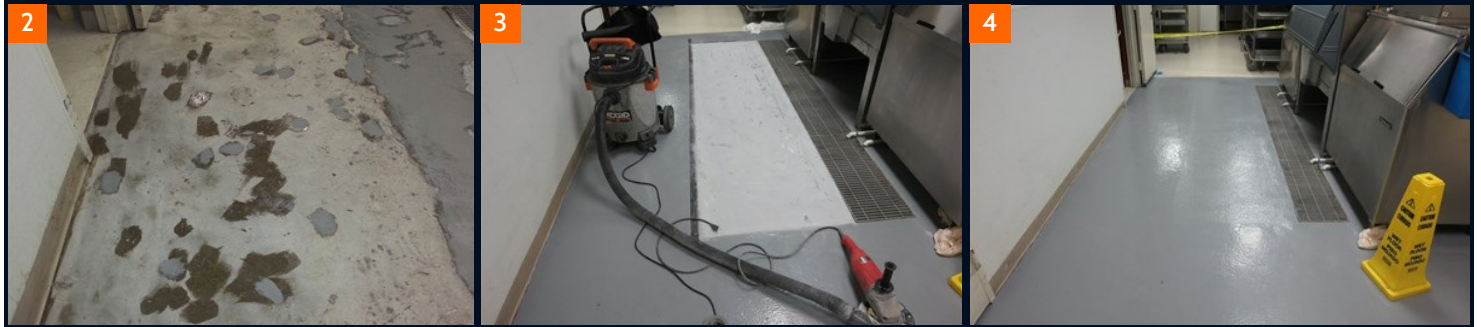
The VCT square tiles were coming up with the water dripping on them from the ice machine, causing a sanitary and slipping problem.

1. Tile removed
2. Floor levelled with Belzona 4131
3. Coated floor prepared for nonskid
4. Completed floor application

The application was carried out in accordance with Belzona Know-How System Leaflet FPA. The tile was removed and the floor was levelled with Belzona 4131. A coat of Belzona 5811 was applied over the whole area and a coat with aggregate was applied in front of the ice machine.
