# BELZONA STOPS THE LEAKS ON HVAC TUBES

ID: 57

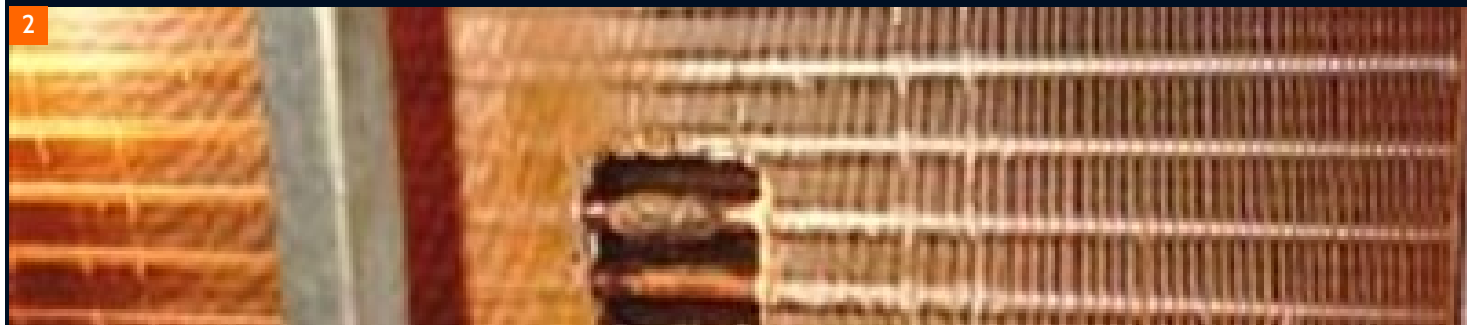
Leaking coolant

Tube in HVAC coil

1. An area was cut to gain access to the leaking pipe
2. Leak stopped with Belzona 1111 (Super Metal)

Application was carried out in accordance with Belzona Know-How Leaflet VPF-11a.

After six years the repair is still in place.

Belzona1111 (Super Metal)
