# CLARIFIER HEADWORKS GET QUICK FIX WITH BELZONA

ID: 5702

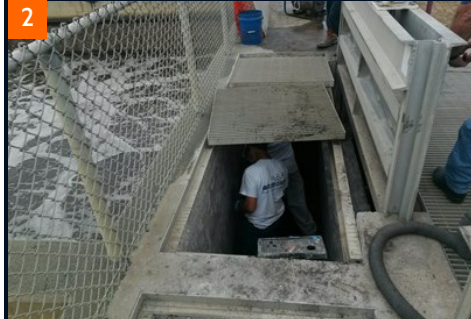
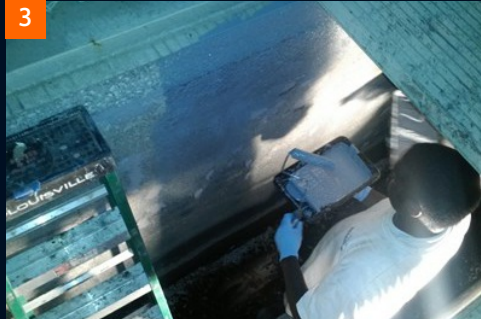
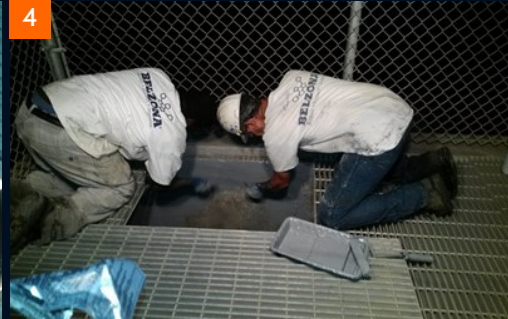
The headworks of a clarifier were covered with a plate to reduce H<sub>2</sub>S odor. This caused chemical attack to the concrete.

1. Blasting the headworks
2. Bugholes filled with Belzona 4111
3. Application of the first coat of Belzona 5831
4. Application of the final coat of Belzona 5831

The application was carried out in accordance with Belzona Know-How System Leaflet TCC. The concrete was blasted and bugholes were filled with Belzona 4111. Two coats of Belzona 5831 were then applied.
