# LIVE WATER LEAK CLAMPED WITH BELZONA

ID: 5704

Hot water line at a hospital

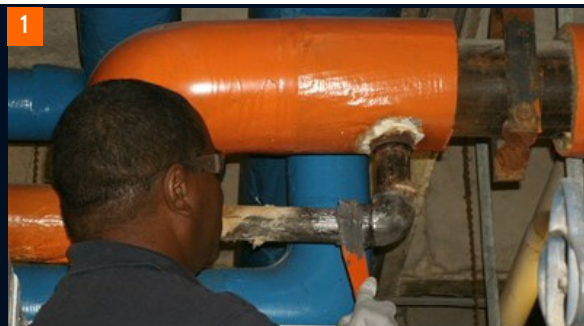
The hot water line was leaking from an expansion tank to the 2" line. The supply of hot water could not be shut off since it fed water to the emergency room.

1. Leaking pipe cleaned
2. Clamp ready to go
3. Application of Belzona 1111
4. Clamp installed

A clamp was fabricated at a machine shop. The clamp had a threaded drain and matched threaded fittings. Belzona 1111 was applied to secure clamp to the hot water line.
