# BELZONA ENGINE BLOCK REPAIR AND PROTECTION

ID: 572

Engine block

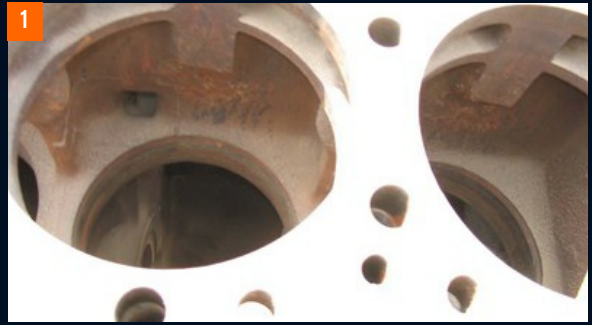
Cavitation and corrosion in water passages of engine block.

1. General view of the block
2. Cavitation area after blasting
3. Rebuilding cavitation area using Belzona 1311 (Ceramic R-Metal)
4. Applying Belzona 1391 (Ceramic-HT) to the block
