# PINTLE HOUSING REPAIR WITH BELZONA

ID: 573

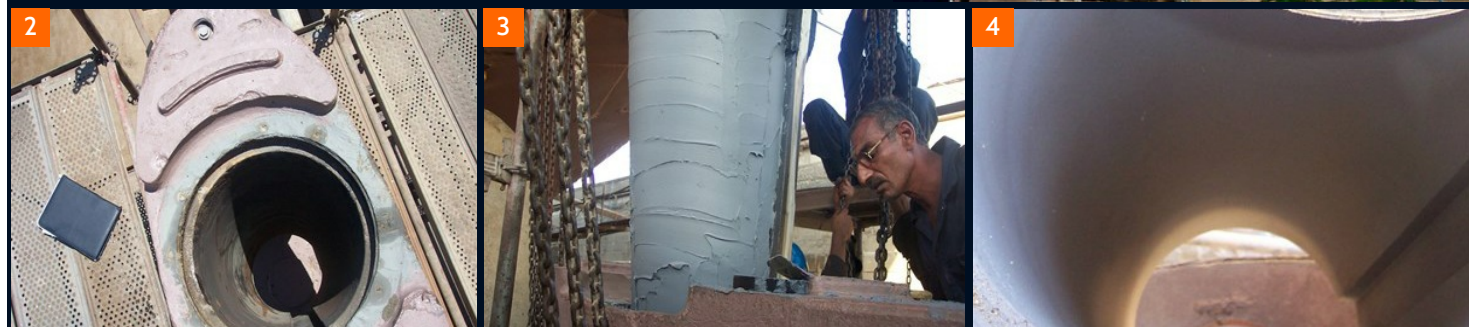
Pintle housing had become oversized due to corrosion.

1. General view of the ship
2. The oversized pintle housing
3. After applying Belzona Release Agent to the pintle, Belzona 1121 was applied to the pintle
4. Pintle housing was perfectly repaired

Belzona was used to allow an in-situ repair with minimum repair downtime. The other option of welding and machining would be difficult to accomplish, potentially dangerous due to heat distortion, and significantly more expensive.
