# MAKE HAY WHILE THE SUN SHINES

ID: 576

Damaged obsolete U.S. Royal 5.50-16 implement tread tire from J.I. Case 140w hay baler.

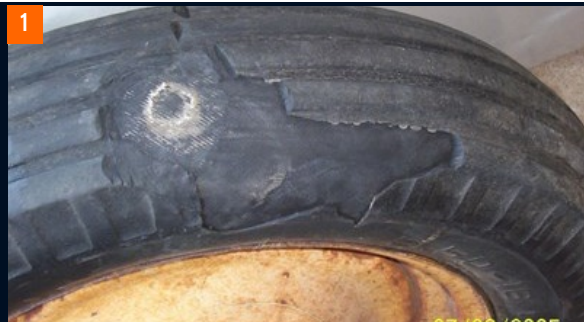
Tire was damaged but cords still in good condition. No replacement available.

1. Damaged tire.
2. All loose rubber removed from tire.
3. Release agent was applied to a mold. Belzona 2211 was applied to the tire and mold.
4. The tire repaired.
