# BELZONA GIVES NEW LIFE TO GROCERY STORE FLOOR

ID: 5772

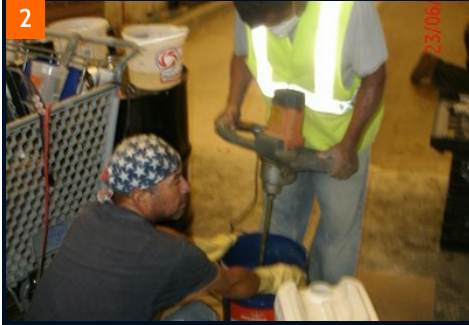
1. Preparation completed and conditioned with Belzona 4911
2. Mixing station
3. Application in progress
4. Completed application

The floor was ground and conditioned with Belzona 4911 to prepare the surface for application. Then, 1/4 of Belzona 4111 was applied to level the floor.
