# LEAKING VENT SEALED WITH BELZONA

ID: 5773

Leaking vent

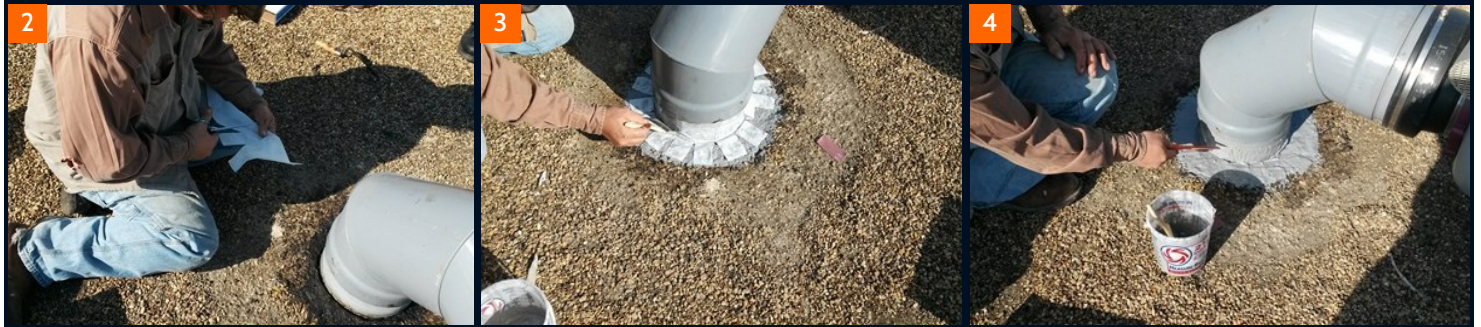
## PHOTOS

A roof vent was installed, but ponding water leaked through the black mastic roof sealer.

1. Newly installed vent
2. Prepared area
3. Fabric being applied
4. Completed application

The application was carried out in accordance with Belzona Know-How System Leaflet RPA-1. The surface was prepared by scraping away the gravel. Then, Belzona 3121 was applied with fabric to seal the duct.

The roof was leaking in the production area from the vent. It was sealed the day before it rained, saving a production shutdown.
