# BONDING SUPPORT PADS WITH BELZONA

ID: 578

Oil pipeline crossing desert from oil field to marine terminal

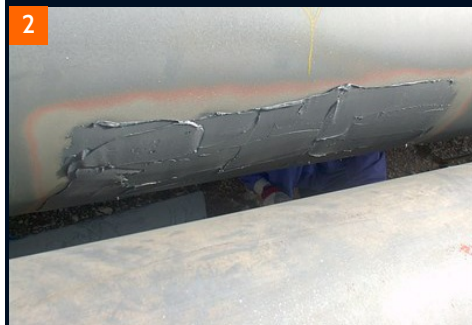
Corrosion and wear of pipes in area of supports caused by the constant thermal expansion and contraction.

1. The working environment
2. Bond area on pipeline grit blasted and Belzona 1121 applied to wet out the surface
3. Wear pad strapped into place and exuded material being faired off
4. Completed application with pipe sat on support

Application was carried out in accordance with Belzona Know-How System Leaflet VPF-15.

Extended working life of Belzona® 1121 allows pads to be bonded effectively in the high desert temperatures. Over 300 pads have to be bonded to the pipeline.
