# HOTEL HOT WATER TANK RESCUE WITH BELZONA

ID: 5780

Potable hot water tank at a large hotel.

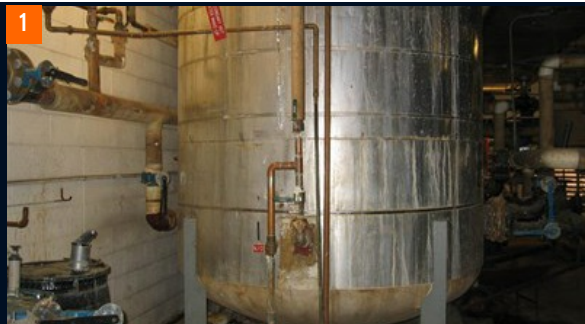
The hot water tank had been built into the mechanical room in a way that it was impossible to remove and replace it without resituating the whole set up of the room. It had sufficient damage on the interior due to corrosion and buildup of minerals and sediment over the years.

1. Hot water tank in the back corner of the mechanical room
2. Interior of the tank showing the corrosion and buildup of sediment
3. Interior repaired and ready for coating
4. Tank repaired and coated, looking like new!
