# BELZONA REFURBISHES ALL VALVES DURING F.S.O. REFURBISHMENT

ID: 579

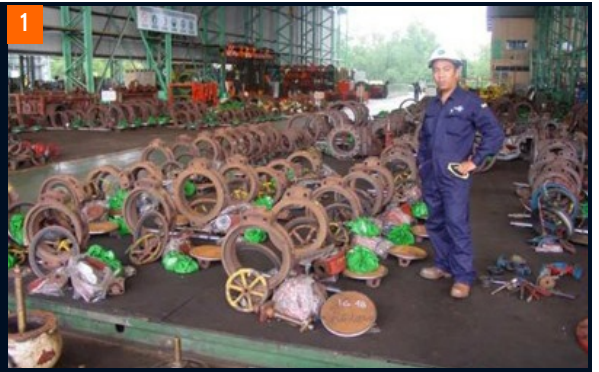
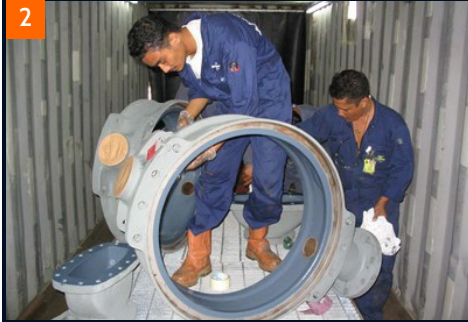
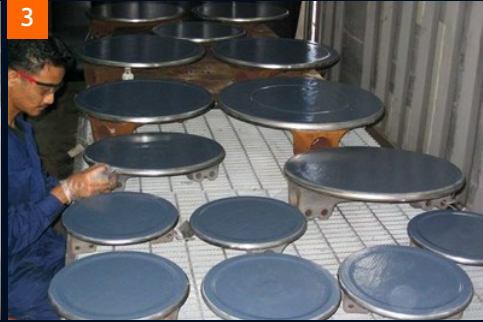
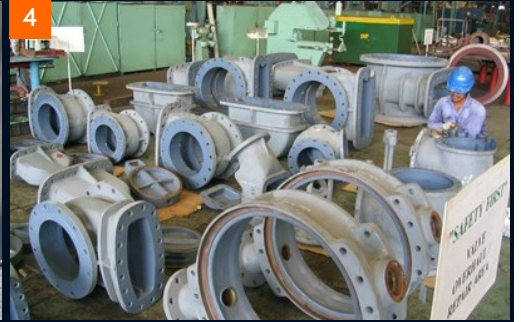
More than 200 valves including butterfly, globe and gate types in many sizes required refurbishment and corrosion protection during the refurbishment of the FSO.

Some of the many valves to be refurbished Application to valve bodies underway Some of the many valve discs protected Completed gate and butterfly valve bodies

Application was carried in accordance with Belzona Know-How System Leaflets VPF-1 & VPF-2.

Belzona 1311 (Ceramic R-Metal) Belzona 1321 (Ceramic S-Metal)
