# BELZONA ANTI-CAVITATION SYSTEM PROTECTS NAVAL VESSEL

ID: 5795

Naval vessel rudders.

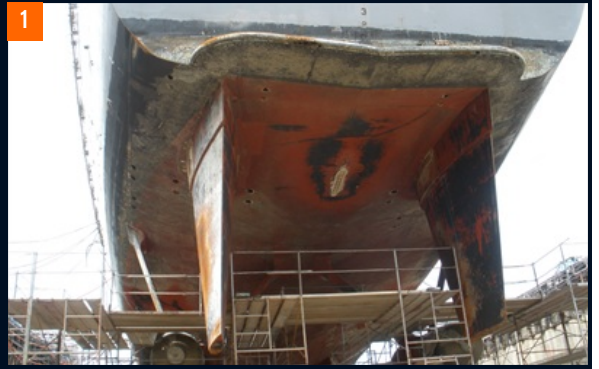
Due to the shape of the rudders, coupled with disturbed water flowing from the propeller, and the high manoeuvrability of the vessel, cavitation damage occurs leading to severe erosion corrosion pitting.

1. Overview of the rudders
2. Close-up view of a damaged area
3. Belzona 1341 applied as the first coat
4. Application completed with a coating of Belzona 2141
