# BELZONA REPAIRS STAINLESS STEEL ARROW IN GRANITE

ID: 5798

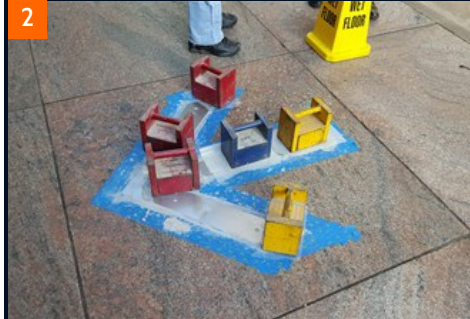
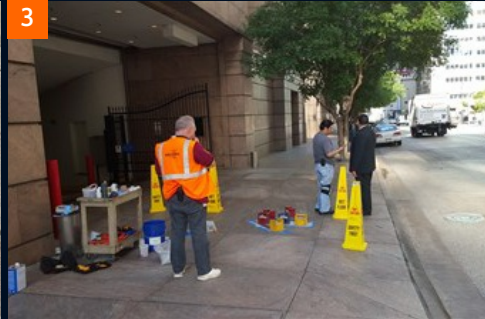
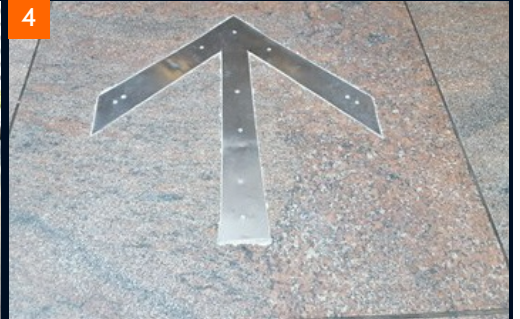
## PHOTOS

Two stainless steel arrows direct traffic into and out of the building. These arrows suffer from the force of tires as the cars accelerate up the slight ramp. The granite was rough hewn in the arrow inset as well as the driving and walking surfaces, which dislodged the arrow from the granite inset. This made cleaning and roughing of the granite difficult. Grit blasting was not possible and grinding was deemed to only affect the "top of the peaks". An alternate was needed since various methods had been tried to no avail. Only a 4 hour window was allowed for the application before cars ran on it. The surface temperature started out at 86°F at 7 AM and rose as noon approached.

1. Surface prepared and masked off.
2. Belzona 4111 applied and weighed down to cure.
3. Waiting on material to cure. Only a 4 hour window.
4. Finished successful application.

The day before the application the back of the arrow was roughened using a diamond 4" disc grinder producing a very rough crosshatched surface. The granite was cleaned of old bonding material using a twisted wire brush. This left a thin layer of metal on the surface of the granite that would not wipe off. Klenztone #1 was used carefully only to the inside of the inset in the granite using a brush and a back and forth motion. This loosened the smeared metal. After sitting 20 minutes the Klenztone was removed with a bucket of water. The next day the granite was dry and any oil on the prepared arrow and granite was removed. The resins were mixed and a light coating of resins was applied to the back side of the arrow and the granite inset to ensure total contact of Belzona 4111. Aggregate was added to the mixed resin to produce a thick gravy type mix. This was applied to the bottom of the granite inset and the back of the arrow.
