# BELZONA MAIN INTAKE PUMPS

ID: 58

Four main intake pumps at power plant

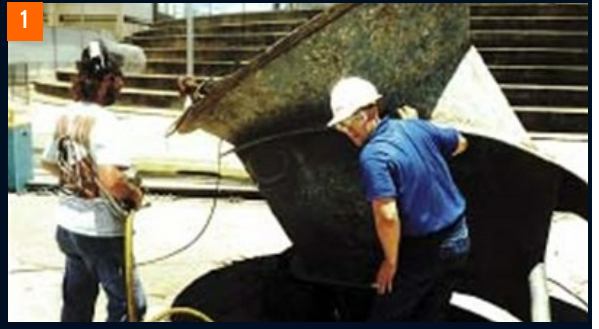
A hole in the diverter caused turbulence and erosion within the pump.

1. Hole in diverter is patched
2. Work commences
3. Erosion damage rebuilt with Belzona 1311 (Ceramic R-Metal)

Application was carried out in accordance with Belzona Know-How Leaflets CEP-3, CEP-5, and CEP-6.
