# BELZONA REBUILDS OVERSIZE KEYWAY

ID: 580

Shaft from double suction split case centrifugal pump.

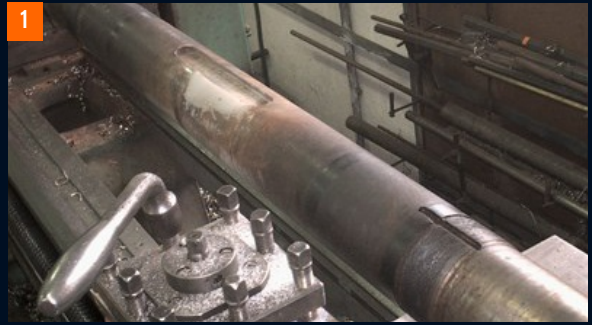
Broken edge of the keyway seat. Insufficient contact area for the load transmission.

The worn keyway Surface prepared  
Keyway being bedded into Belzona

Belzona repair provided a low cost alternative to welding and re-machining with a fast return to service. The repair was still in service when checked (June 2007).
