# BELZONA PROTECTS ROAD SWEEPER BOX AGAINST CORROSION

ID: 5802

Road sweeper box.

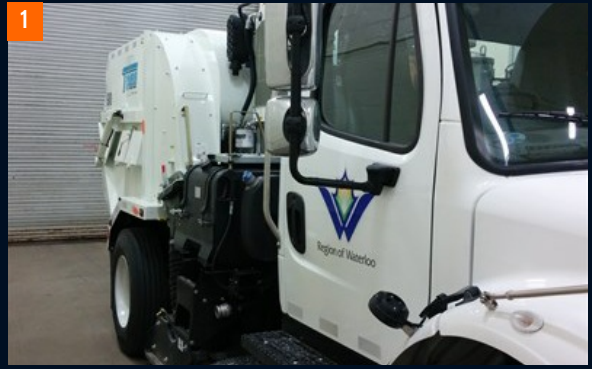
The sweeper box was suffering from corrosion from the inside, thus shortening the life of the unit.

1. View of road sweeper
2. Prior to application
3. Completed application
4. Completed application

The application was carried out in accordance with Belzona Know-How System Leaflet TCC-3 for repairing/renewing damaged linings. A high powered pressure washer was used to prepare and clean the inside of the sweeper box. Belzona 6111 was spray applied to the surface as the first coat. Within the recommended overcoat time, Belzona 5111 was spray applied as the second coat.
