# BELZONA BRINGS BACK LIFE TO 20 YEAR OLD TRANSFORMER

ID: 5805

A 20 year old transformer is part of a substation which helps supply power to local residence.

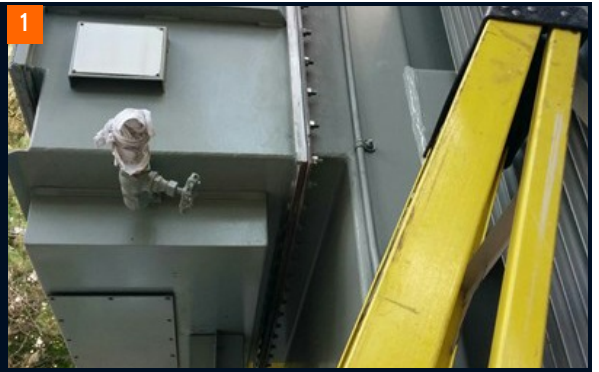
The transformer was temporarily drained and shut down due to leaking oil contaminating the surrounding ground soil, which was a safety and environmental concern.

1. View of the transformer
2. Preparation in progress
3. Close up view of application
4. Completed application
