# END COVER OF CONDENSER RECEIVES BELZONA HT SOLUTION

ID: 5806

End cover of condenser. Design temperature: 130°C; design pressure 0.1MPa

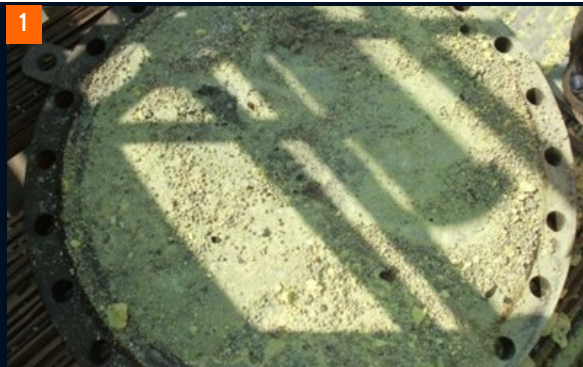
Severe pitting corrosion appeared on the cover after years of operation. The worst pitting is about 10mm deep.

1. The internal surface before application
2. Severe pitting damage
3. Completed application
4. The coating after 4 years shows no sign of further corrosion

Application was carried out in accordance with Belzona Know-How System Leaflet HEX-3. Belzona 1511 was used to rebuild the profile followed by an application of Belzona 1591 as a high temperature protective coating.

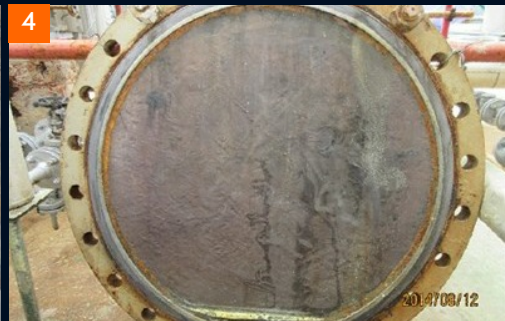
The cover was originally unlined. Belzona's solution prevented the cover from further corrosion, extended the equipment life and eliminated the cost of replacement. After 4 years in service, the coating is in perfect condition.
