# BELZONA REPAIRS AND PROTECTS SEA WATER CIRCULATION PUMP

ID: 5807

The casing of sea water circulation pump

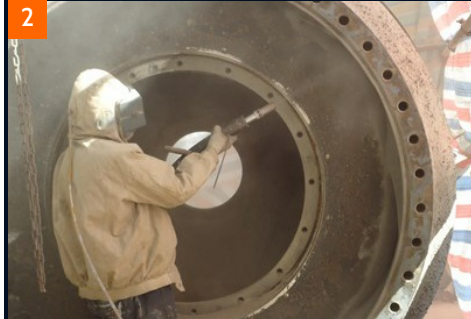
After years of operation, the casing was badly eroded and damaged by the sea water

1. Overview of the circulation pump
2. Surface preparation by grit blasting
3. Close-up view of the damaged area after the blasting
4. Completed application

The application was carried out in accordance with Belzona Know-How System Leaflets CEP-1 & CEP-3. Holes were repaired with Belzona 1311. The high spots were ground down to smooth the surface and Belzona 1341 then applied.
