# BELZONA REPAIRS AND PROTECTS CHILLER UNITS FROM CORROSION

ID: 5808

Holding Pans in chiller units.

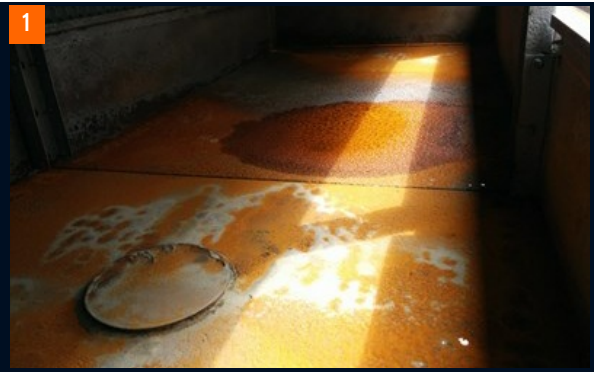
The holding pans in the chiller units had corroded and required immediate attention.

1. Prior to application
2. Preparation in progress
3. First coat of Belzona 5811
4. Completed application

The application was carried out in accordance with Belzona Know-How System Leaflet TCC-15 for sealing and protecting containment areas. To prepare the holding pans, a grit blaster was used to remove the corrosion. Belzona 1111 was used to plate bond patched and to seal all edges and joints. Two coats of Belzona 5811 were applied to the units in accordance with Belzona Instructions For Use.
