# BELZONA STOPS TANK LEAK

ID: 5809

Water Tank

Power Plant, Northern Texas, USA

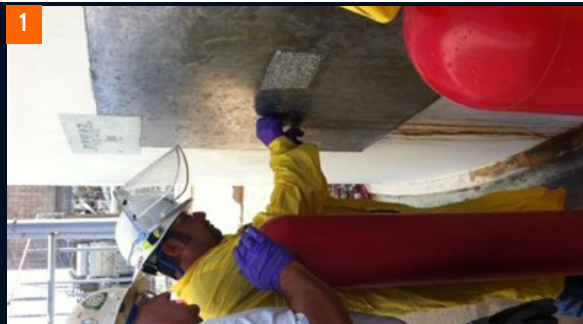
Emergency water tank was thin walled and leaking. Welding produced more leaks. The tank could not be taken out of service. Thin wall and leaks needed to be fixed while the tank was full.

1. Area to be repaired
2. Stopping leaks
3. Applying Belzona 1111
4. Completed repair

The application was carried out in accordance with Belzona Know-How System Leaflet TCC-1. The tank was blasted, which revealed three active leaks. The leaks were stopped with Belzona 1291. Then the entire area was coated with a fully reinforced Belzona 1111 with Belzona 9311.
