# BELZONA SEALS ASH TANK ROOF

ID: 5811

Roof of ash tanks in the power plant

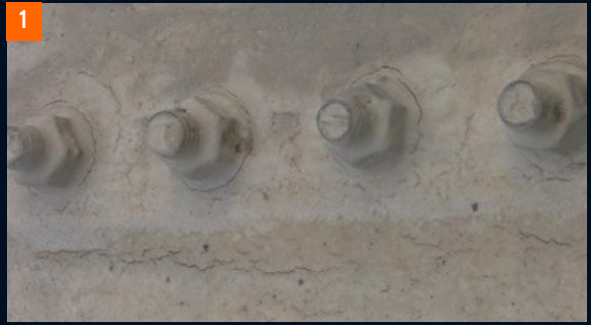
After years of service, the steel plates had started leaking. Two other coatings were applied but both failed.

1. The previous coating failed within 1 year. The cracks in the joint caused leaking
2. The repair work was completed with Belzona solution
3. Overview of the completed application
4. After 7 years, the repair still in perfect condition

Application was carried out in accordance with Belzona Know-How System Leaflet FPA-6, RPA-1 and 6. The joints were sealed with Belzona 2211, before applying a fully reinforced Belzona 3111 Flexible Membrane system.

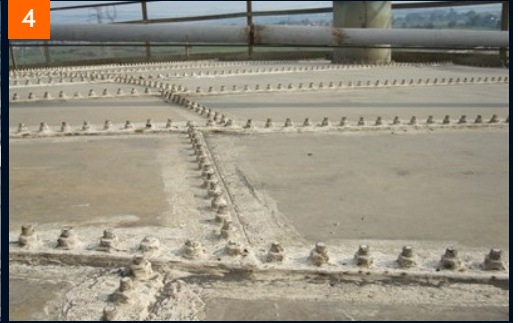
Belzona solution for tank roof offers longer service than the conventional welding. The performance is far superior than other coatings the client tried. This cost effective solution won client's trust. After 7 years in service, the repair work is still in perfect condition and the client is looking to have more roofs repaired by Belzona.
