# BELZONA REPAIRS AND PROTECTS CONCRETE AROUND HANDRAIL POSTS

ID: 5813

Concrete around handrail posts at a Water Treatment Plant.

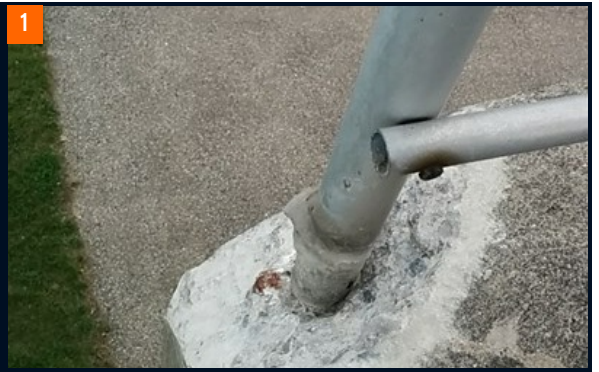
The concrete around the handrail posts was badly spalled. Some of the damage was from a combination of environmental (freeze thaw effect) and proximity of the concrete to the clarifier tanks.

1. Top view of damaged concrete
2. Side view prior to application
3. Top view of completed application
4. Completed application

The application was carried out in accordance with Belzona Know-How System Leaflet FPA-10 for fixing or securing anchor bolts or handrails. A grinder was used to prepare the surface and any loose concrete was removed. Belzona 4911 was applied to the prepared surface using a stiff bristle brush. Belzona 4131 was applied in accordance with Belzona Instructions For Use.
