# SPALLED STEPS NO LONGER A SAFETY HAZARD WITH BELZONA REPAIR

ID: 5814

Stairs to a memorial recreation center.

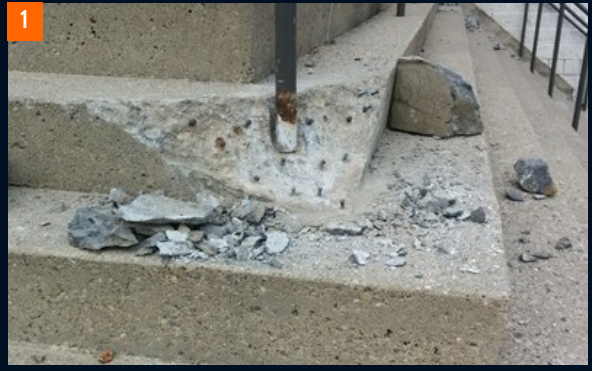
The stairs had spalled due to environmental freeze and thaw effect.

1. Prior to application
2. Completed application
3. Completed application

The application was carried out in accordance with Belzona Know-How System Leaflet FPA-10 for fixing or securing anchor bolts or hand rails. The surface was prepared using a grinder and the surface was brushed to remove any loose concrete. Belzona 4911 was applied to the area using a stiff bristle brush. Belzona 4131 was applied directly onto the conditioned surface in accordance with Belzona Instructions For Use.
