# PIPE ELBOW REPAIRED AND PROTECTED WITH BELZONA

ID: 5815

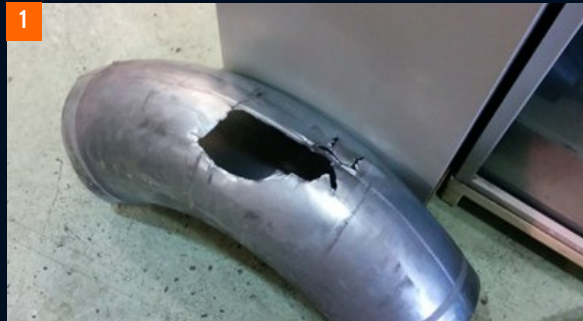
The blast material going through the pipe wore a hole to the side of the pipe elbow.

1. Prior to application
2. Application in progress
3. Completed application
