# BELZONA REPAIRS CLARIFIER WITH 2" GOUGE

ID: 5816

Clarifier in a Waste Water Treatment Plant

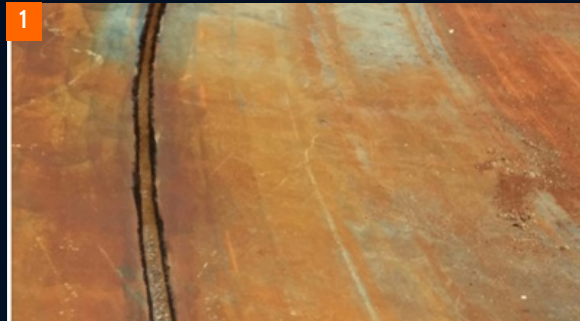
The sweeper arm in the clarifier had sagged over the year's and had worn a 2 inch gouge around the diameter of the tank.

1. Prior to application
2. Application in progress
3. Completed application

The application was carried out in accordance with Belzona Know-How System Leaflet FPA-1 for rebuilding worn and damaged floor surfaces. The damaged area was manually prepared to remove any scale and debris. Belzona 4911 was applied to the surface using a bristle brush and Belzona 4131 was applied to the damaged area in accordance with Belzona Instructions For Use.
