# BELZONA REPAIR OF TWO STAGE PUMP

2 Stage Centrifugal Pump (Model 3B200x2)

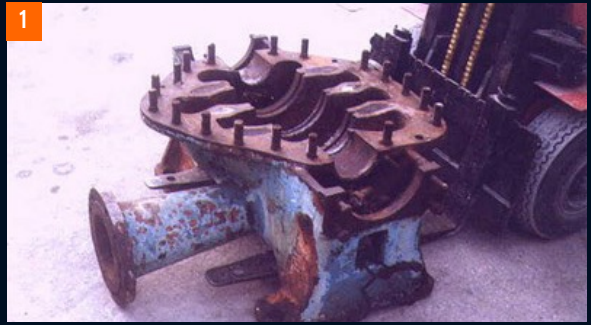
Erosion, wear and corrosion of sealing elements and pump casing.

1. Pump surface before preparation
2. Belzona 1321 applied to grit blasted surface
3. Refurbishing seal ring seats and bearing seats by forming
